RR607/RR6088 Trailer Trouble Shooting:

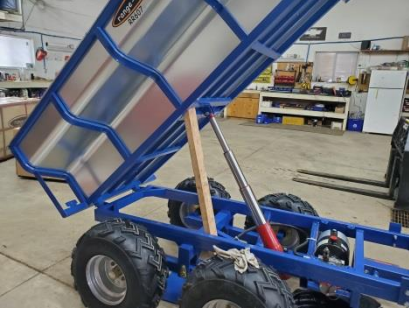
- 1) Use a 2x4 or other strong material to prop the tub/deck solidly, this support will be holding the full weight of the tub/deck in the air so make sure it is strong enough.

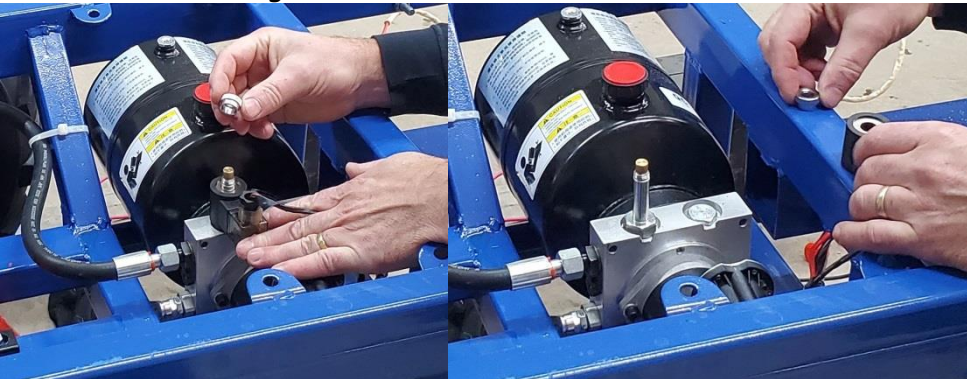
- 2) Use the remote control to lower the cylinder, putting all of the weight on your support and taking the pressure off the hydraulics.
- 3) Undo the nut holding the solenoid and the remove the solenoid, this nut is only hand tight.

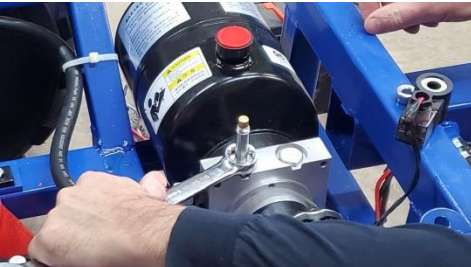
- 4) Use a 15/16 wrench to undo the solenoid housing slowly.

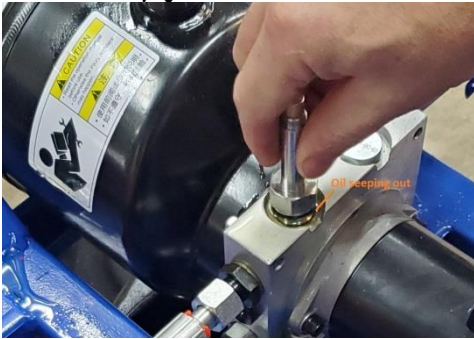
5) When oil starts to seep out of the threads, stop turning until there is no pressure left in the oil coming out, usually just a few seconds.

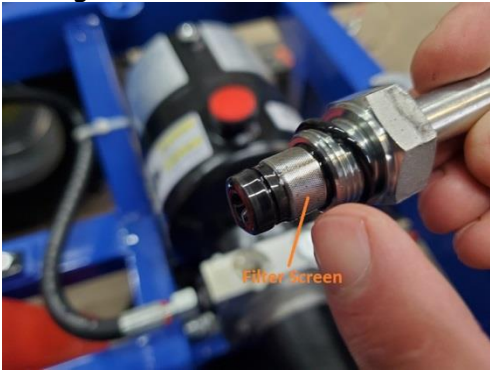
6) When you pull the housing out you will see the stainless steel screen that needs cleaned, use brake cleaner or degreaser and a brush to clean the screen out. Screen can be removed if necessary for cleaning.

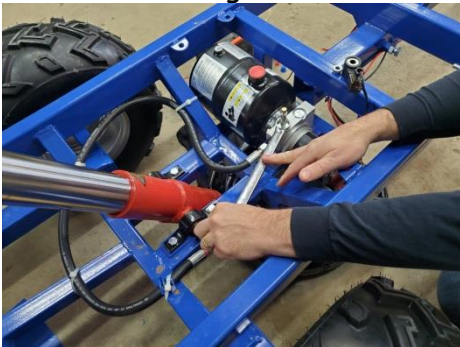
7) Re-install housing with clean filter using 15/16 wrench.
